**1. IDENTIFICATION / RECOGNITION**

**System Overview**

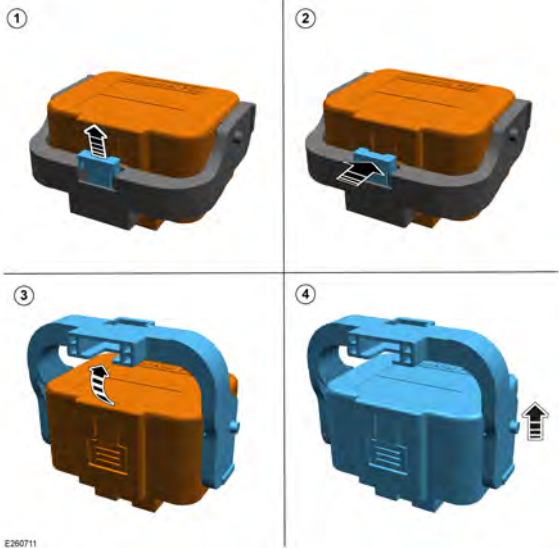
E280711

Then follow the 4 stage process shown to remove the MSD from the High Voltage battery.
